bigHead vs Competitor product

Tensile Load Performance, Weld Quality & Dimensional Accuracy Evaluation

Purpose of test: **To determine the tensile load-to-failure performance values, weld quality and general product integrity**

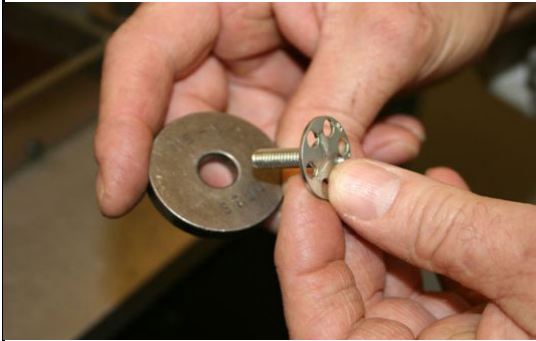
Loading fastener to test rig - Step 1

Test configuration: **Axial "straight pull". Fastener gripped by M6 thread & pulled through 11mm diameter aperture**

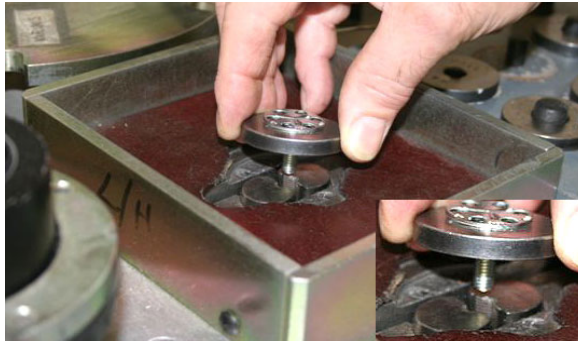
Loading fastener to test rig - Step 2

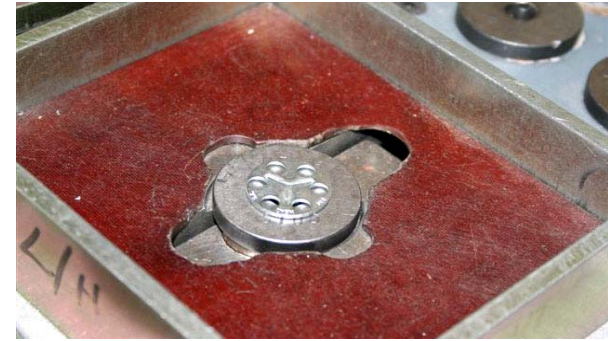
Loading fastener to test rig - Step 3

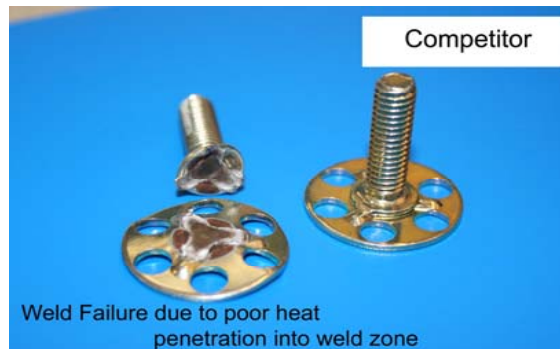
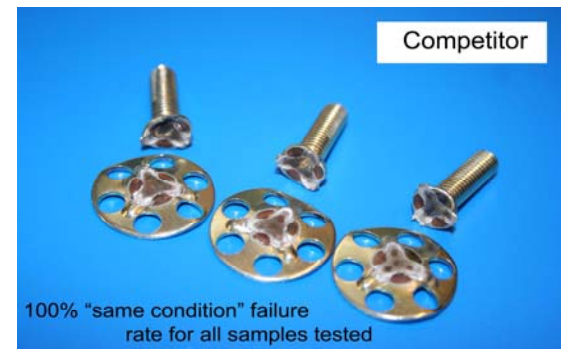
Competitor's Test samples

Test Sample	Test Type	Test Equipment	Description of Test	LOAD TEST RESULT (in KN)	Failure Mode	Comments	
COMPETITOR Test Sample 1	Tensile	Hydraulic test rig (Semi-automated)	Vertical pull, sample constrained in planes 'X' & 'Y'. Component loaded (inverted) into pull-tester, with stud passing through a predefined aperture. Part gripped from underside and pulled vertically downwards. Test loading applied axially, through centreline of fastener.	1.22	100% WELD FAILURE	Fusion of parent metals within weld zone less than 20%. Poor heat penetration during weld cycle. Fusion temperature not achieved, resulting in molecular union only at the surface of the welded joint (stuck weld). Stud pulled from head (disc) at very low load condition, indicating weld quality well below acceptable limit of performance for product type	
COMPETITOR Test Sample 2	Tensile	Hydraulic test rig (Semi-automated)		2.90	100% WELD FAILURE

COMPETITOR Test Sample 3	Tensile	Hydraulic test rig (Semi-automated)		1.23	100% WELD FAILURE		
bigHead Test Sample 1	Tensile	Hydraulic test rig (Semi-automated)			5.42	NO VISIBLE FAILURE OF WELD. DISC "CROWNED" AND PULLED THROUGH APERTURE.	100% fusion of parent metals achieved. Welded joint of head to stud remained intact throughout test, with no visible separation seen. Part welded to acceptable standards of performance.
bigHead Test Sample 2	Tensile	Hydraulic test rig (Semi-automated)			5.54	NO VISIBLE FAILURE OF WELD. DISC "CROWNED" AND PULLED THROUGH APERTURE.	
bigHead Test Sample 3	Tensile	Hydraulic test rig (Semi-automated)			5.08	NO VISIBLE FAILURE OF WELD. DISC "CROWNED" AND PULLED THROUGH APERTURE.

Of the 4 Competitor test samples selected:

3 were load-tested; none reached minimum acceptable performance limits for product material/type.
